NASA TECHNICAL NOTE

NASA TN D-1861

EXPERIMENTAL INVESTIGATION OF
INSULATING REFRACTORY-METAL
HEAT-SHIELD PANELS

by Gregory R. Wichorek and Bland A. Stein

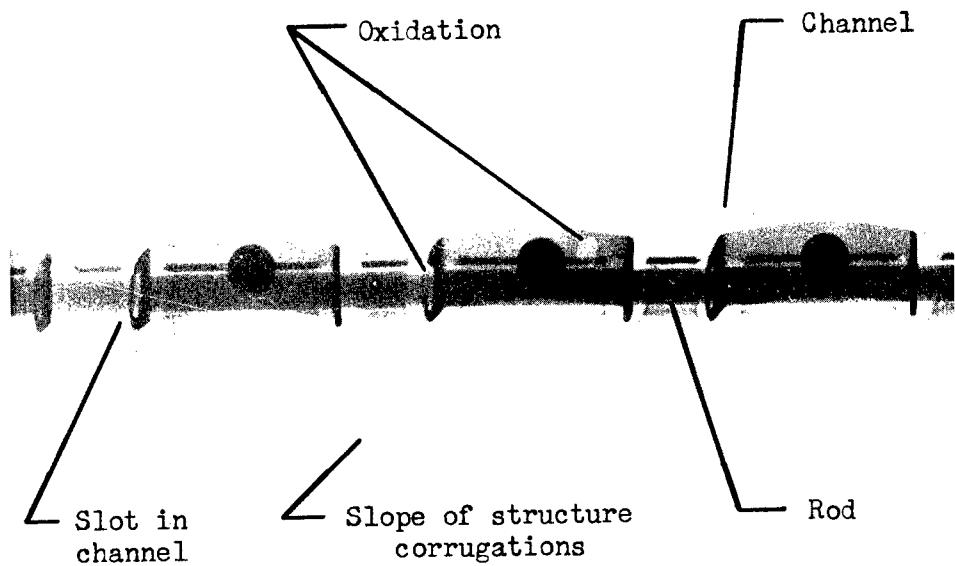
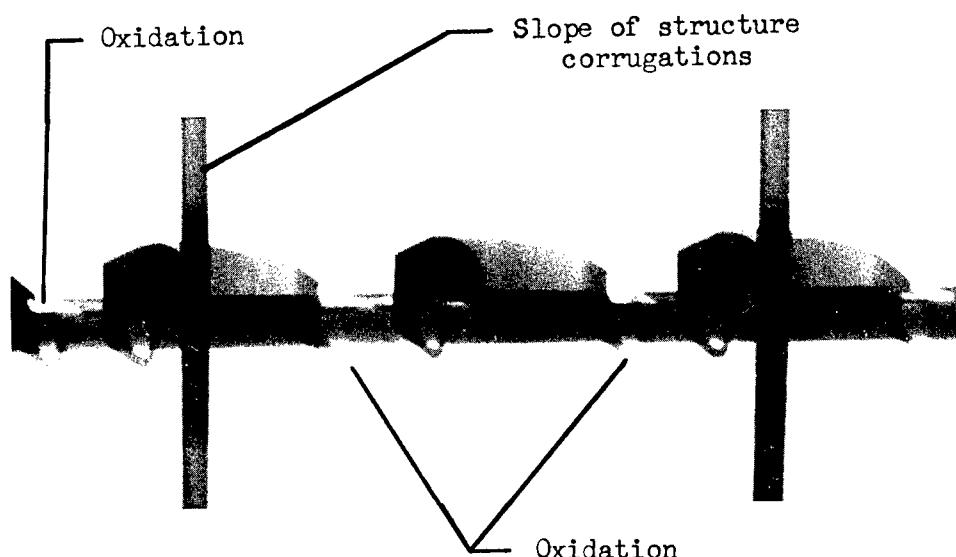
Figure 10.- Radiographs showing deterioration of coated molybdenum-alloy panel.

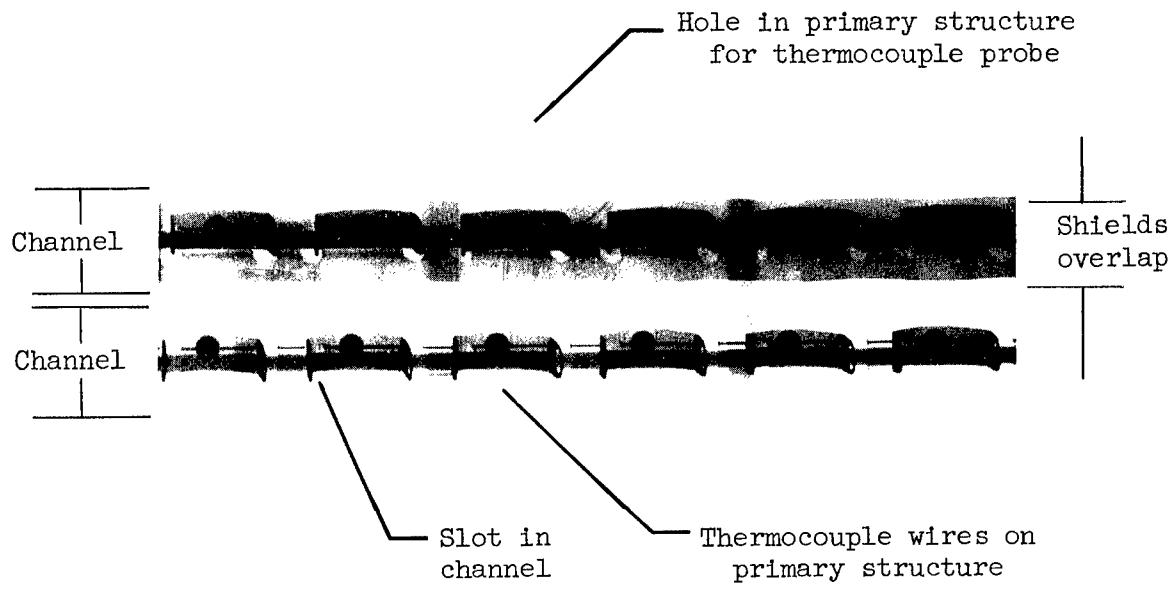
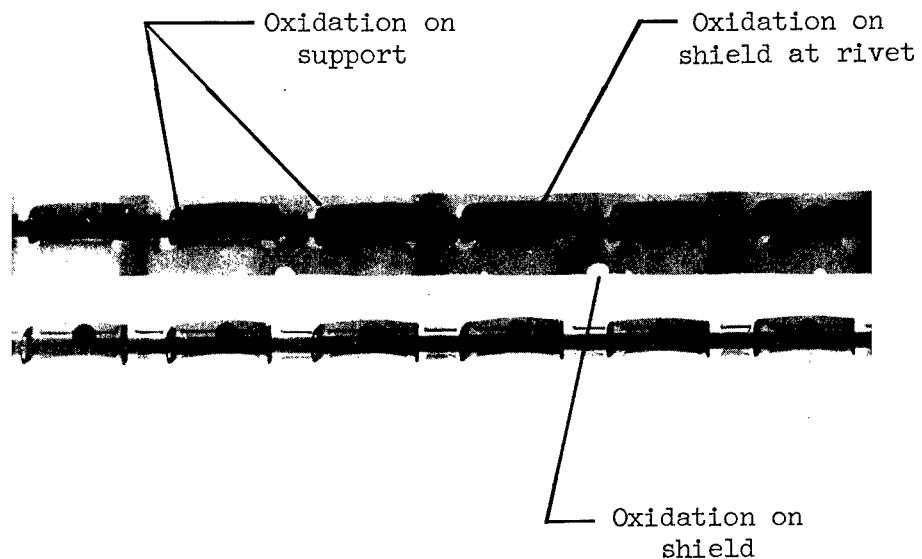
Coating failures along the edges of the outer skins occurred during the first heating cycle. Based on the results of the cyclic-heating tests performed on the small riveted configurations, these edge failures were considered to be premature. Damage to the coating along the edges of the outer skins may have occurred during the assembling, X-raying, and mounting of the panel for testing. Consequently, the need for extreme care in the handling of coated specimens is indicated. Coating failures on the surface of one of the outer skins occurred during the second heating cycle. No surface failures were detected on the other two outer skins after five heating cycles. Radiographs indicating the growth of oxidized regions on the coated molybdenum-alloy shields are shown in figure 13.

Figure 13.- Radiographs showing progressive deterioration of coated molybdenum-alloy panel.

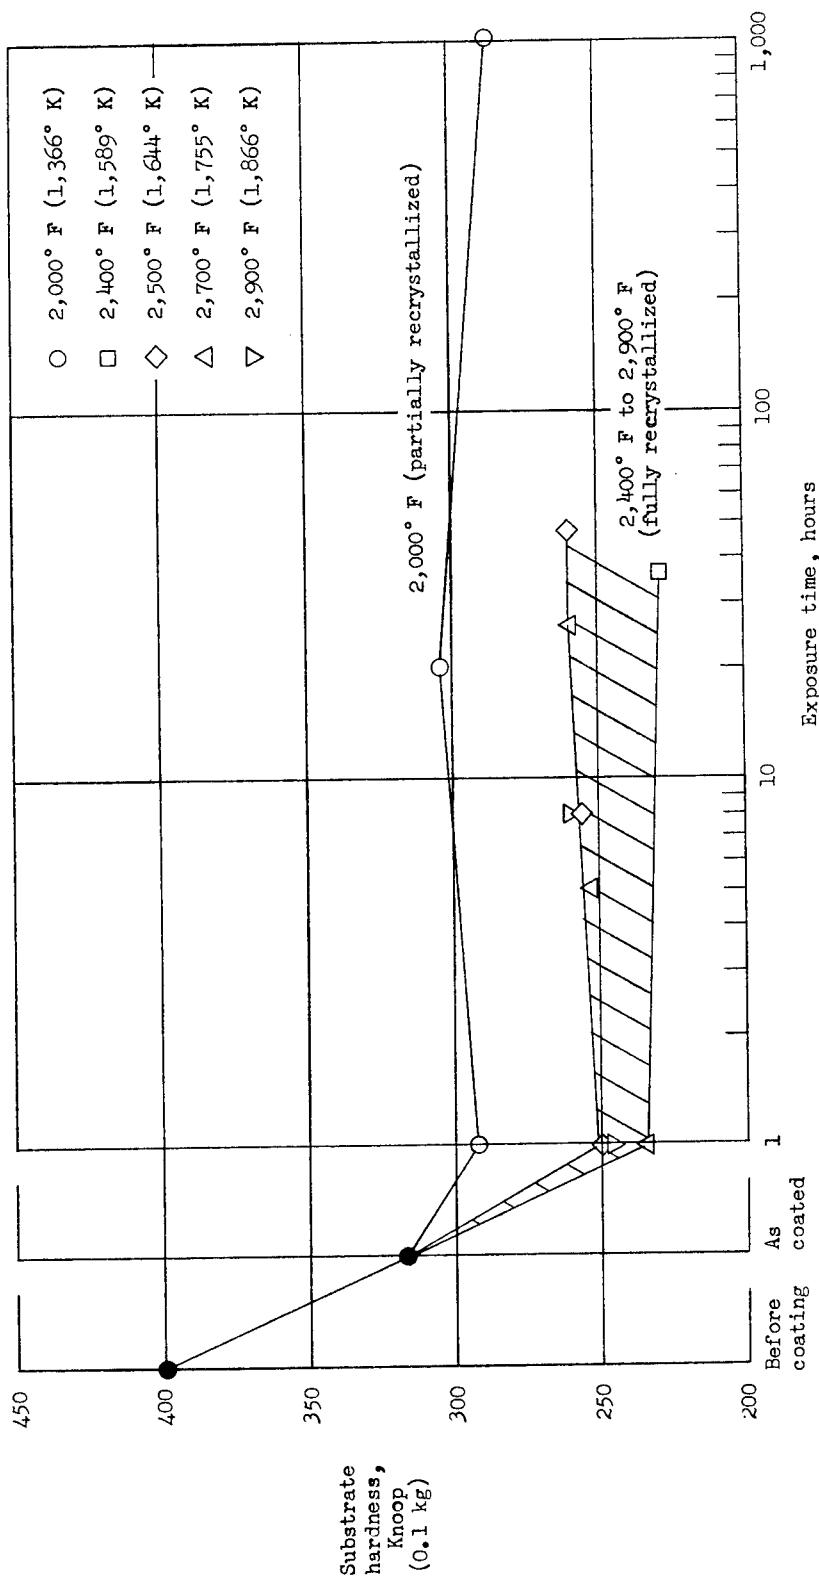
Mechanical-property tests.— The arc-cast molybdenum-alloy sheet used in this investigation was supplied in the stress-relieved condition. This material has a Knoop hardness of 398 (fig. 4 of ref. 6) and a recrystallization time of 1 hour at $2,400^\circ \text{ F}$ ($1,589^\circ \text{ K}$). Typical photomicrographs of the molybdenum-alloy sheet before coating and in the as-coated condition are shown in figure 14. Figure 14(b) shows that a central zone along the midplane of the sheet has been recrystallized by the coating procedure. Approximately 40 percent of the substrate has been recrystallized. Microhardness indentations in the recrystallized and unrecrystallized zones gave uniform Knoop hardnesses of 252 and 361, respectively. The average Knoop hardness, 317, of the as-coated substrate was taken in this case as a weighted average of the values in the recrystallized and unrecrystallized zones. Substrate hardness values for coated molybdenum-alloy sheet were uniform through the thickness for specimens tested at $2,400^\circ \text{ F}$ to $2,900^\circ \text{ F}$ ($1,866^\circ \text{ K}$). Hardness values for the recrystallized and unrecrystallized zones in the as-coated material and the specimens tested at $2,000^\circ \text{ F}$ ($1,366^\circ \text{ K}$) were also uniform but of different magnitudes. The variation of substrate hardness with exposure time and temperature is shown in figure 15.

Figure 15.- Variation of substrate hardness with exposure time and temperature for molybdenum-alloy sheet coated with silicide-base coating.

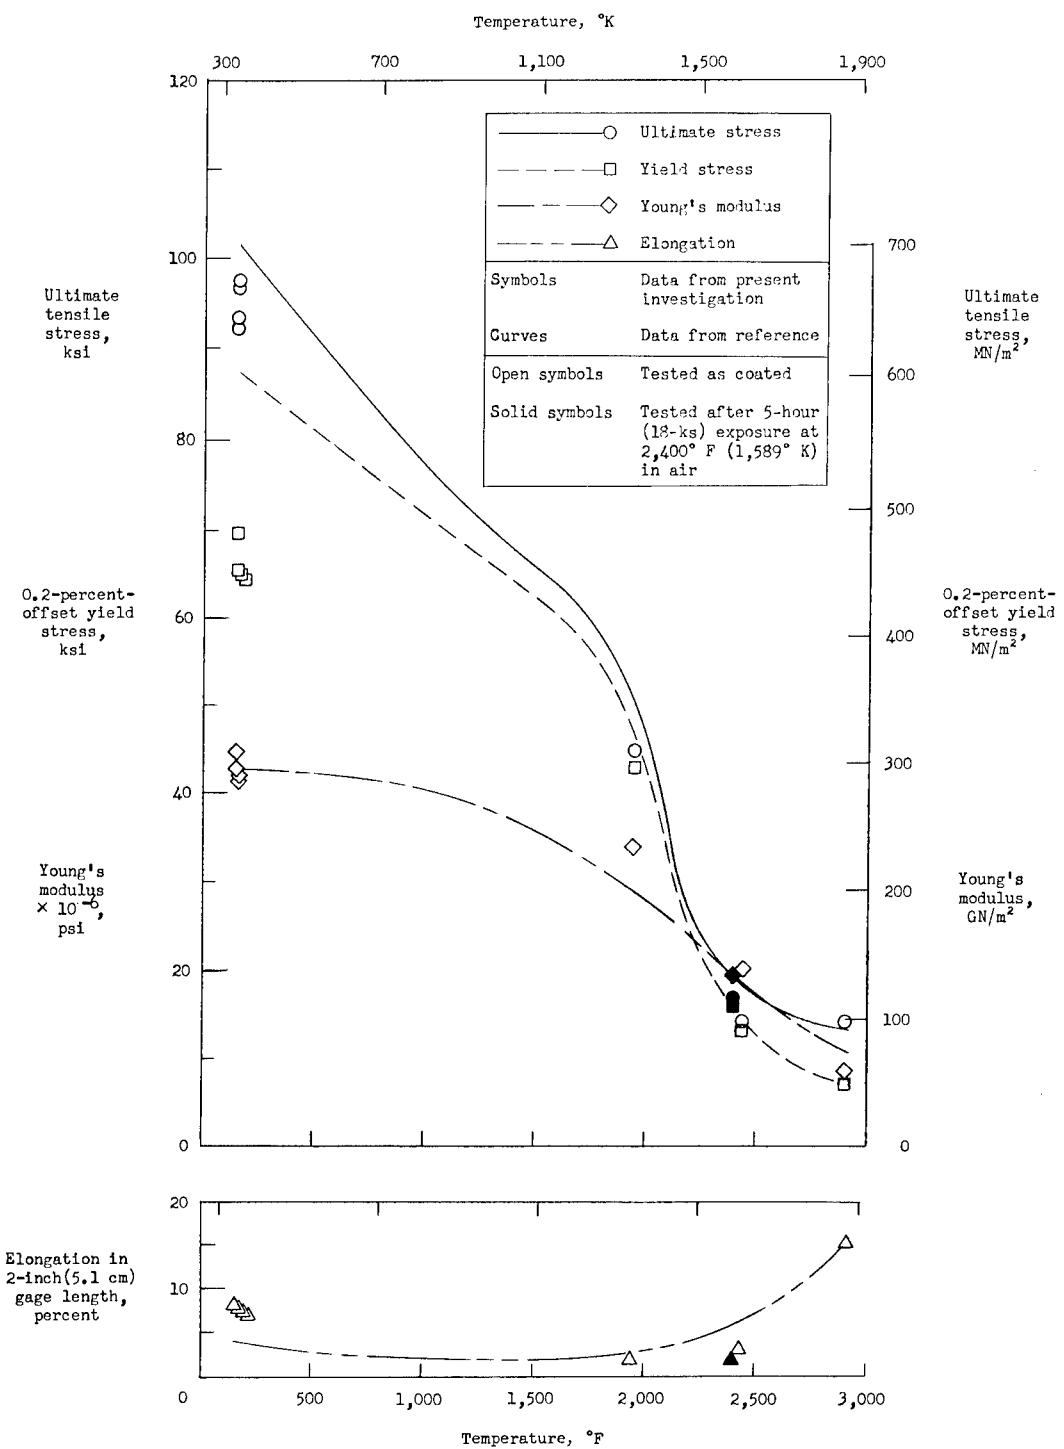
The room-temperature mechanical properties of the as-received molybdenum-alloy sheet, determined from tensile stress-strain tests, are given in table II. The results of tensile tests on the molybdenum-alloy sheet coated with the silicide-base coating at room and elevated temperatures are presented in table III. The tensile properties of the coated molybdenum-alloy sheet are compared in figure 16 with similar data from reference 9 for molybdenum-alloy sheet coated with another silicide-base coating. Figure 16 shows close agreement between the tensile properties of the coated molybdenum-alloy sheets, with the exception of room-temperature yield stress. This difference exists probably because the molybdenum-alloy sheet was recrystallized less than 5 percent by the

Figure 16.- Tensile test results for coated molybdenum-alloy sheet at various temperatures determined in present investigation compared with previous tensile data reported for coated molybdenum-alloy sheet in reference 9.

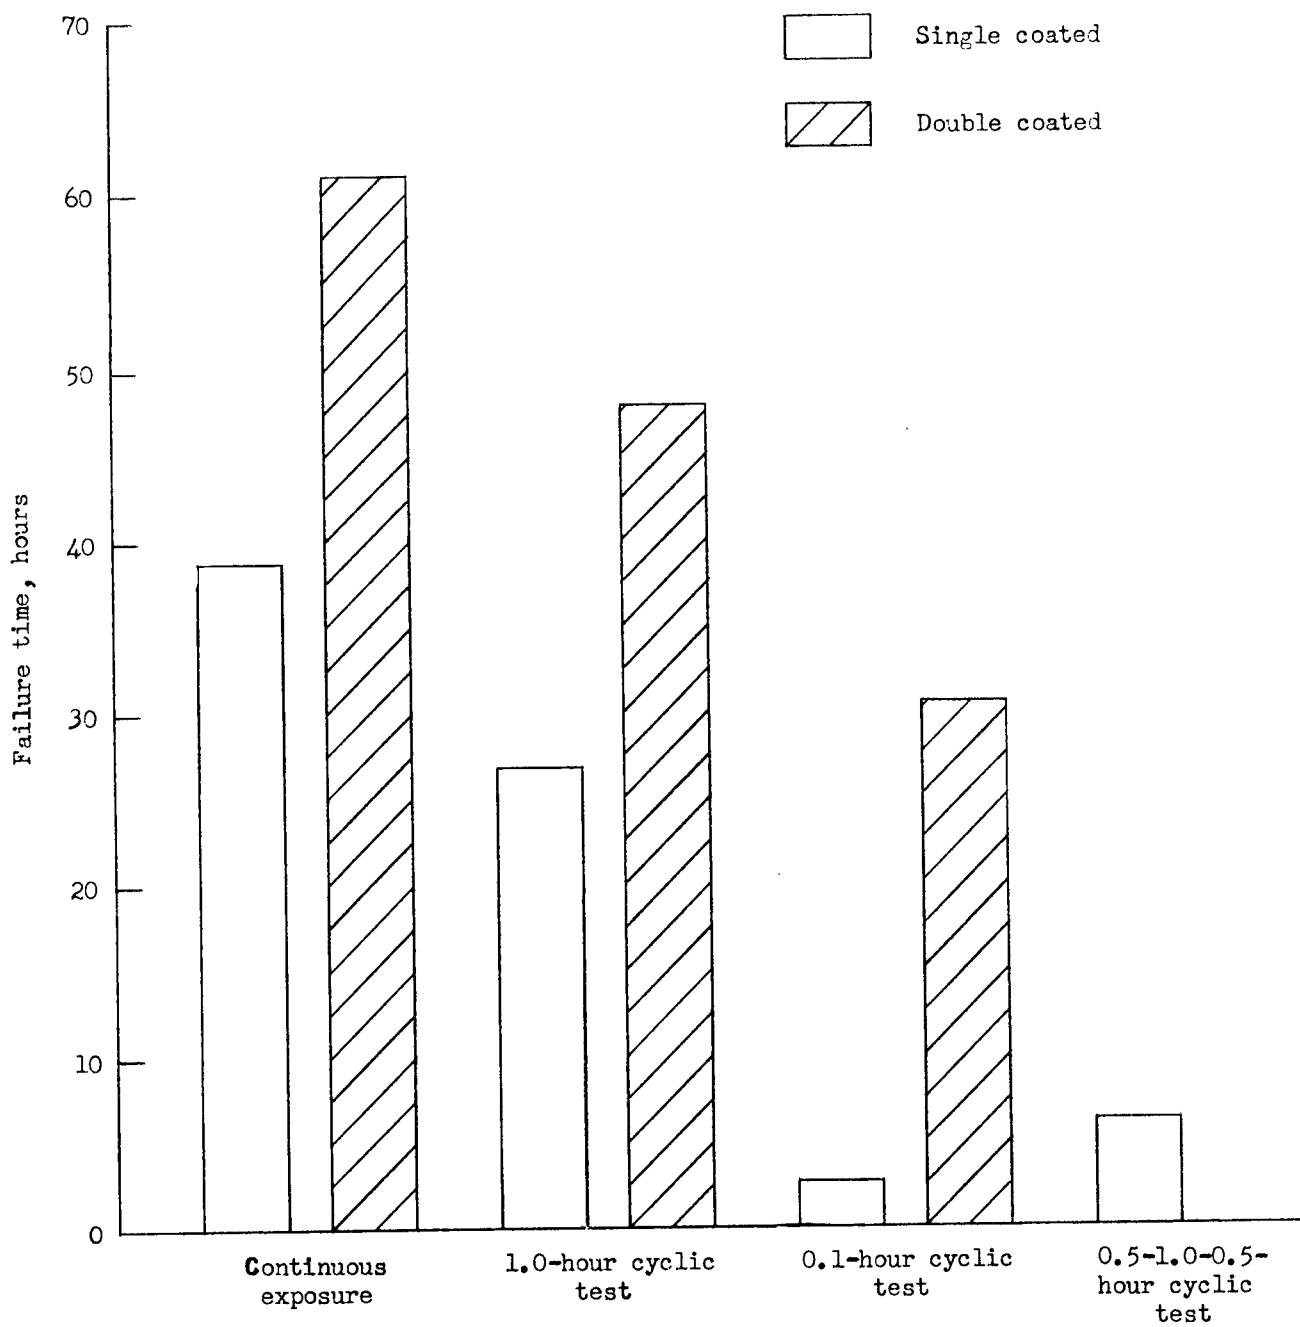
The results of oxidation tests on the molybdenum-alloy coupons coated with the silicide-base coating are presented in table V. Some of the data were previously presented in reference 2, where the coating investigated herein is designated as coating F. Failure occurred first at edges for more than 50 percent of the coupons in the continuous tests and for more than 90 percent of the coupons in the cyclic tests. Coating lifetimes for single- and double-coated coupons exposed to continuous and 1.0-hour cyclic tests are plotted in figure 18. This figure shows that scatter in the cyclic-test data is more evident than in the continuous-test data. The double-coated coupons had longer lifetimes than the single-coated coupons at both 2,000° F (1,366° K) and 2,500° F (1,644° K). The double- and single-coated coupons had approximately the same lifetimes at 2,700° F (1,755° K). This may be explained by a decrease in viscosity of the SiO_2 layer at the higher temperatures, providing for better "self-healing" characteristics. Another factor may be an increase in the initial rate of formation of the SiO_2 layer at the higher temperatures. Figure 19 clearly indicates a reduction in the performance of the silicide-base coating under

Figure 19.- Effect of various test conditions on coating life of coated molybdenum-alloy coupons at 2,500° F (1,644° K).

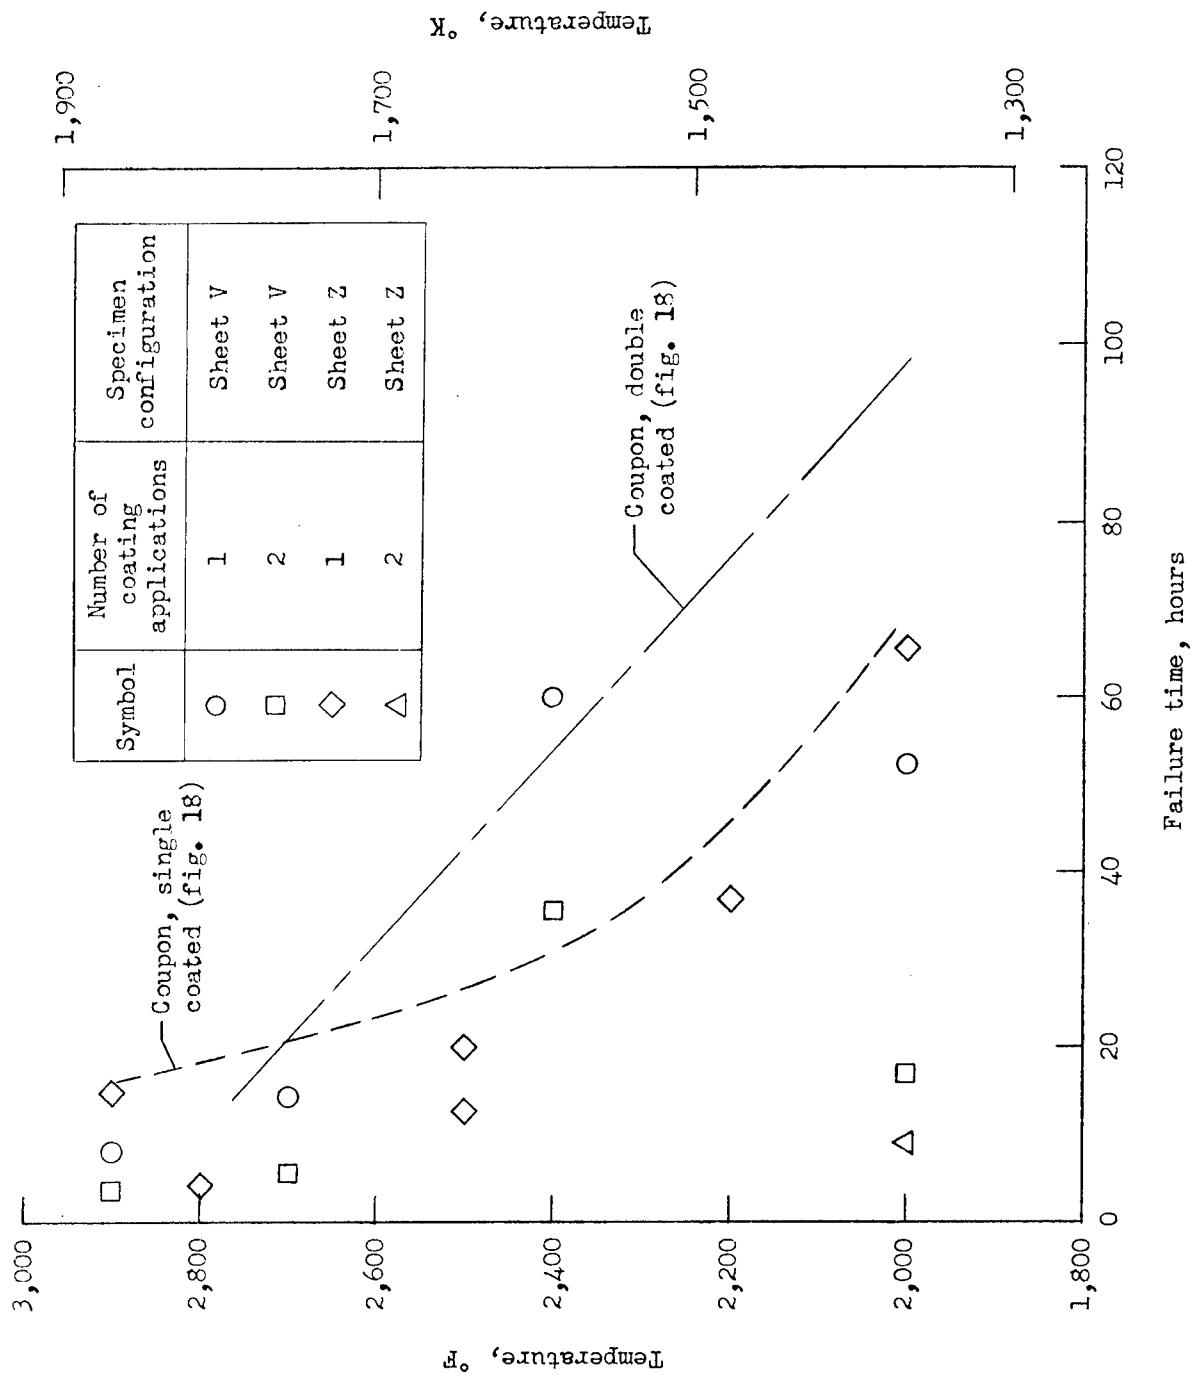
The results of 1.0-hour cyclic oxidation tests on the coated sheet-V and sheet-Z specimens fabricated from the molybdenum alloy are presented in table VI. The coating life of the riveted configurations and the coupons subjected to 1.0-hour cyclic tests are compared in figure 20. Where there was visual evidence of oxidation damage on these specimens, the damage was generally observed after the last or next to the last heating cycle. The single-coated sheet-V and sheet-Z specimens generally exhibited shorter lifetimes than the single-coated coupons, as might be expected. However, the double-coated riveted specimens not only had shorter lifetimes than the double-coated coupons but they also had shorter lifetimes than the single-coated riveted specimens. Therefore, the double-coated riveted specimens may be said to have failed prematurely at all test temperatures from 2,000° F (1,366° K) to 2,900° F (1,866° K). The appearance of sheet-V and sheet-Z specimens before and after 1.0-hour cyclic tests is shown in figures 21 and 22, respectively. In general, the single-coated riveted specimens failed at the rivet, at the edge of the sheet, or in both areas simultaneously. All the double-coated specimens failed at riveted joints. Apparently the riveting operation had severely damaged the first coating and the second coating application did not adequately repair the damaged areas. The test results indicate that the coating of riveted components after fabrication provides better oxidation protection than the precoating, fabrication, and recoating of riveted components.

Figure 20.- Comparison of coating life on small riveted molybdenum-alloy specimens (symbols) with that on sheet coupons (curves) at various temperatures under 1.0-hour cyclic conditions.

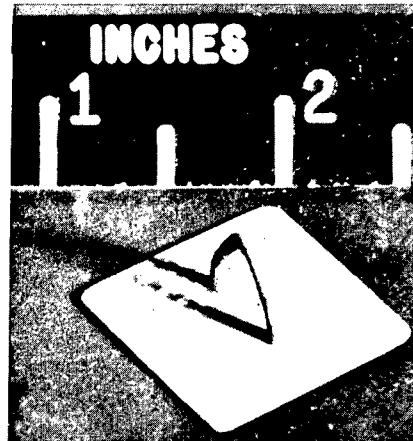
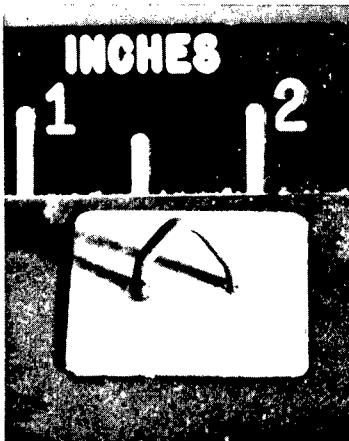
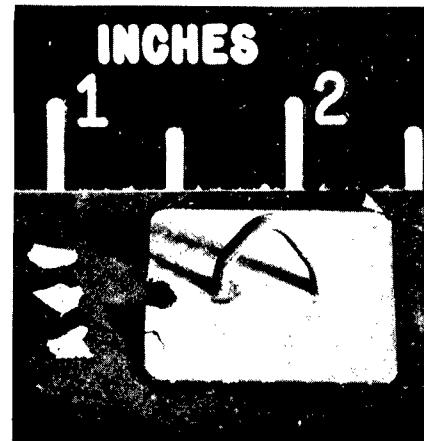
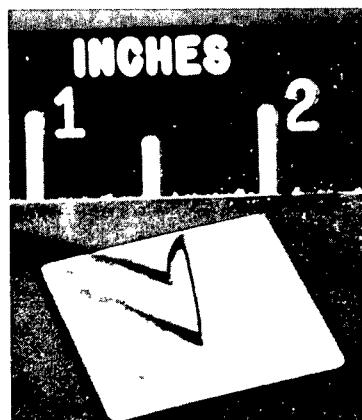
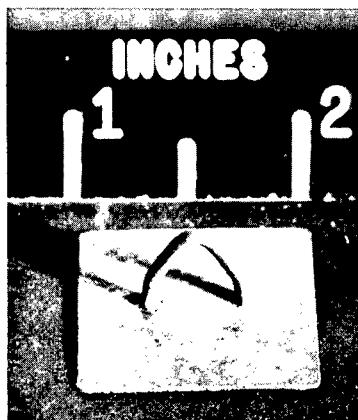
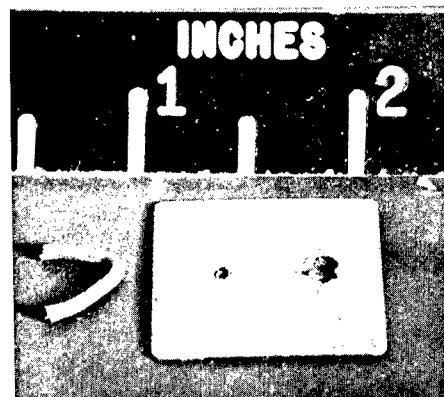
Figure 21.- Molybdenum-alloy sheet-V specimens coated with silicide-base coating before and after 1.0-hour cyclic tests at 2,700° F (1,755° K).

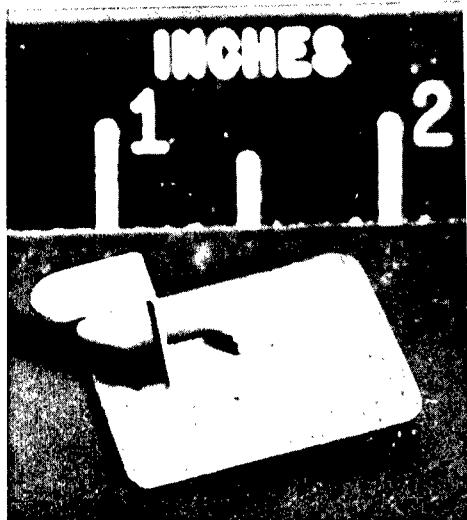
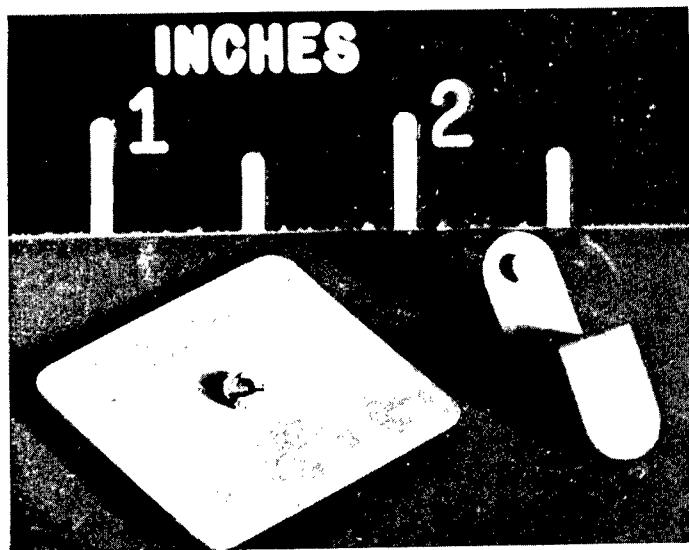
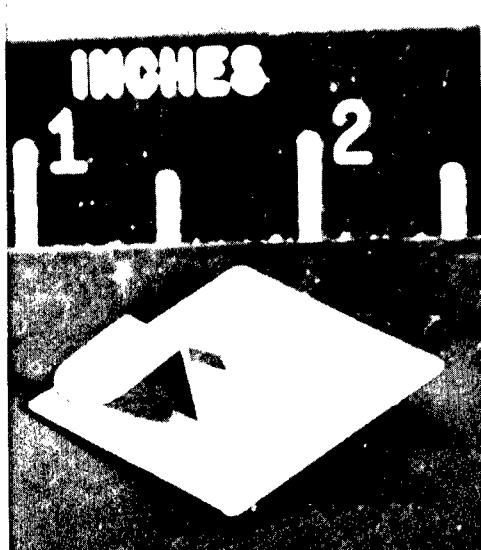
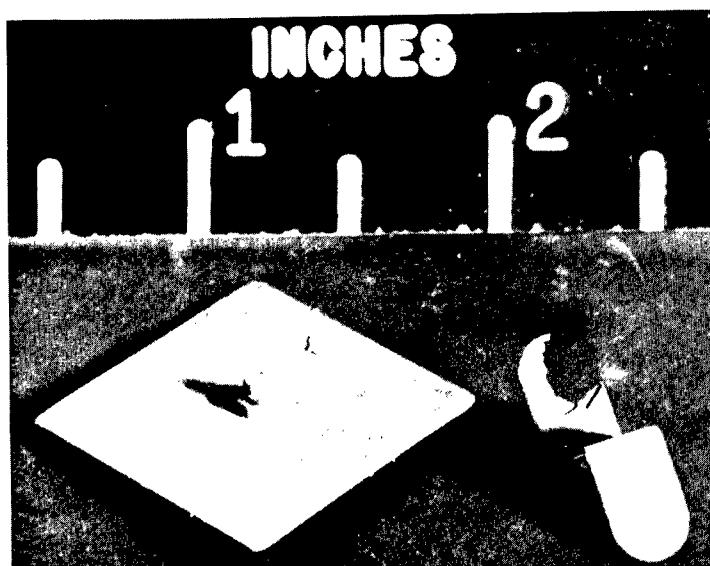
Figure 22.- Molybdenum-alloy sheet-Z specimens coated with silicide-base coating before and after 1.0-hour cyclic tests at 2,000° F (1,366° K).

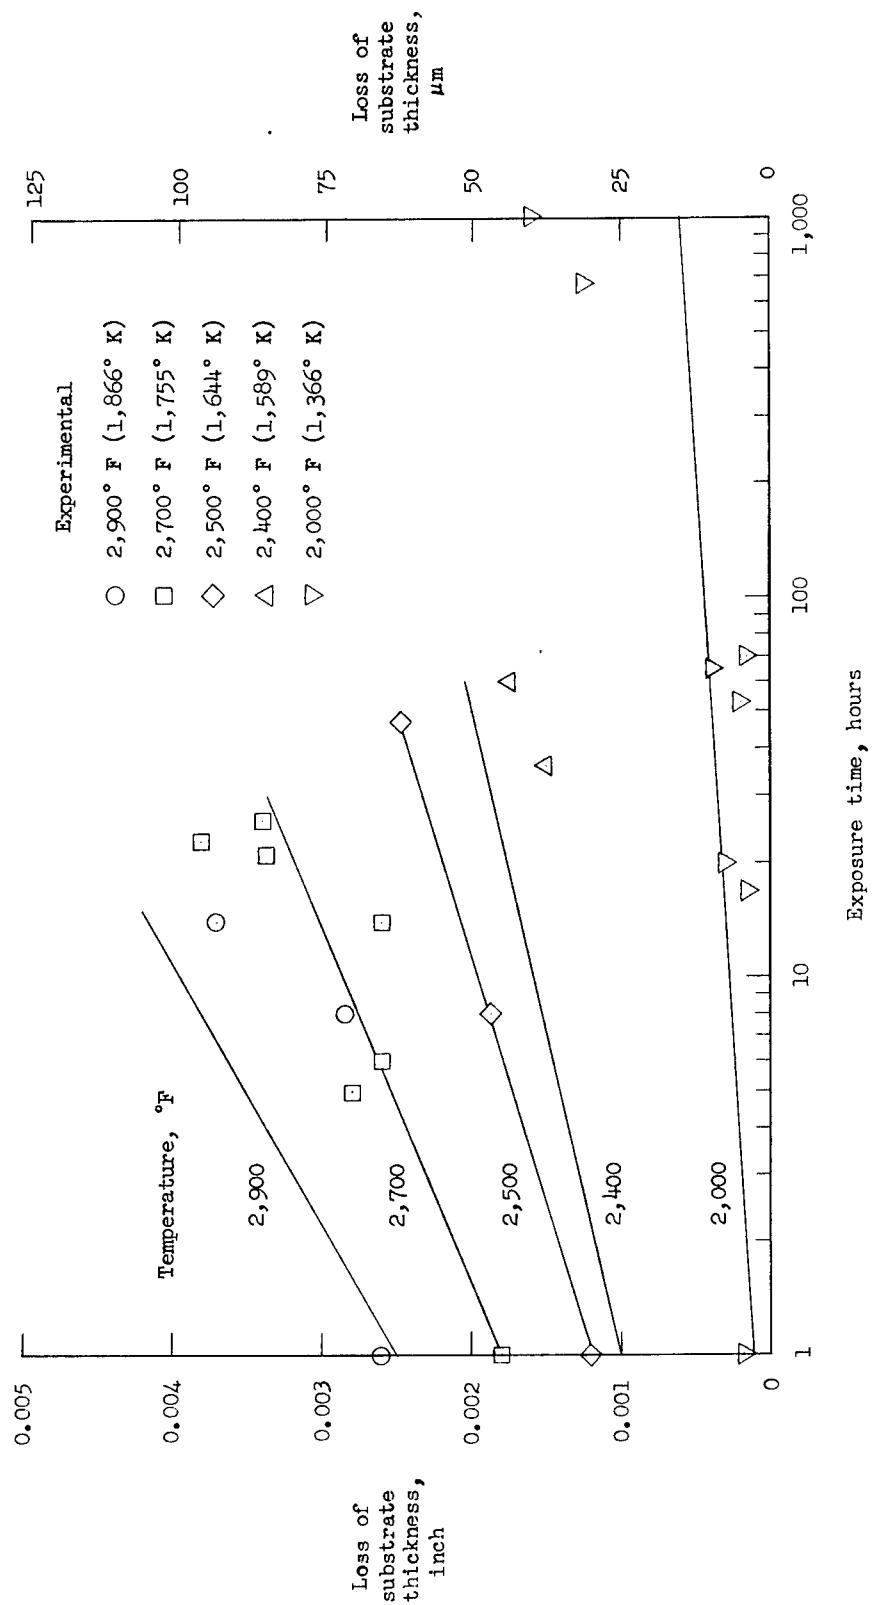
Diffusion of silicon into the molybdenum-alloy substrate occurs when the coating is exposed to high temperatures in air. The various coating phases which form are discussed in appendix C. The loss of substrate thickness due to diffusion is presented in table VII and shown as symbols in figure 23. The curves were obtained by cross-plotting the test data of substrate loss against temperature and were smoothed to give the best possible fit. Although the data show scatter within the test temperatures, the curves give an indication of substrate loss with increasing time and temperature. It is realized that the diffusion mechanisms which operate may change within the time and temperature ranges shown. Most important, the data indicate that solid-state diffusion may be a serious problem when thin-gage molybdenum-alloy sheet coated with the silicide-base coating is used at temperatures from 2,400° F (1,589° K) to 2,900° F (1,866° K).

Figure 23.- Loss of substrate thickness due to diffusion of silicide-base coating into molybdenum-alloy substrate for various time-temperature exposures in air.
